AN ANALYSIS OF INSTITUTIONAL RESPONSIBILITIES FOR THE LONG-TERM  
MANAGEMENT OF CONTAMINANT ISOLATION FACILITIES

Dissertation

Interdisciplinary Studies: Environmental Management

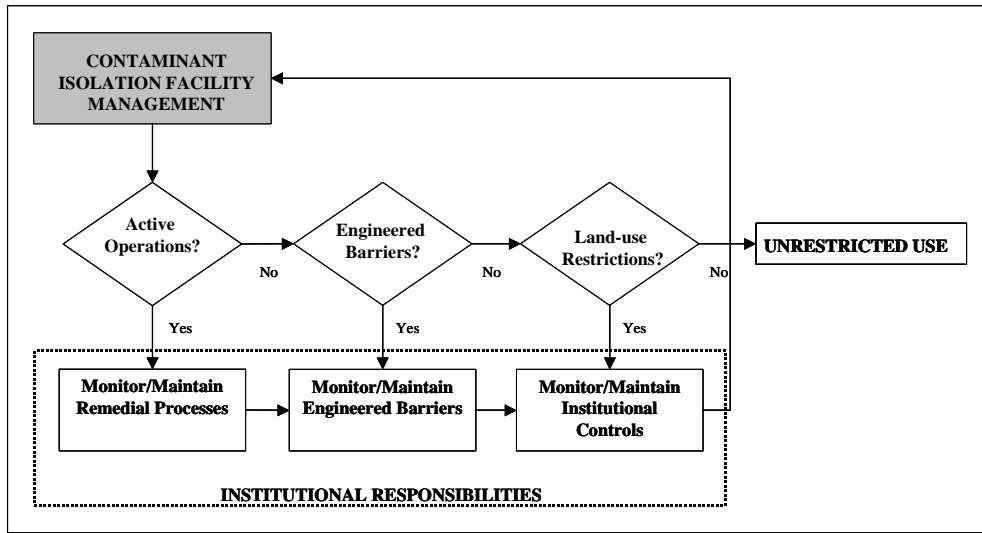
Figure 4. A logic diagram applicable to site stewards for assessing the management functions of a Contaminant Isolation Facility.

Figure 4 illustrates a logic diagram applicable to site stewards for assessing the management function of a contaminant isolation facility. The diagram highlights three operational questions related to the presence of existing subsystem components (Active Operations, Engineered Barriers and Land use Restrictions). A positive response to any of these three questions triggers site-specific requirements. Such requirements could include the monitoring and maintenance of remedial processes, engineered barriers or institutional controls. The site-specific monitoring and maintenance requirements can be viewed as the institutional responsibilities of the site stewards.

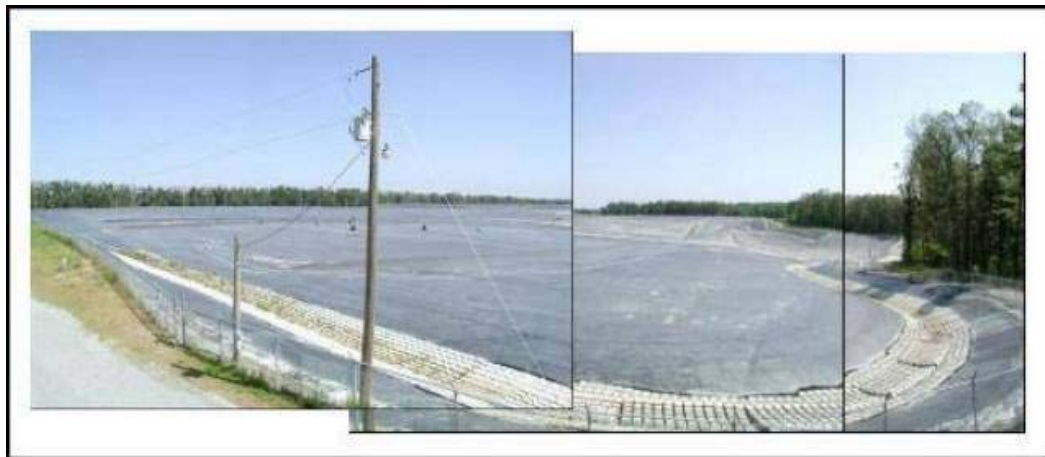
Figure 17. Photograph of the Maxey Flats interim geomembrane-cap.

Approximately one million gallons of contaminated leachate was removed from the original disposal trenches between 1998 and 2000 (USEPA, 2001d). This water was solidified and the resulting “concrete” was disposed of in earth-mounded concrete bunkers that were constructed at the disposal facility. A “natural stabilization” remedy was then selected and implemented for the final remediation of Maxey Flats. This remedy required the “initial” closure of the site, contouring of the site to reduce erosion and the subsequent capping of the site to prevent infiltration. The “interim” remediation cap, shown in Figure 17, was completed in 2003 and consists of a layer of compacted clay (21 inches) and a 40-mil polypropylene liner. This geomembrane-cap covers approximately 60 acres. Monitoring wells have been located under the cap and within the trenches to measure trench water levels. Additional groundwater monitoring wells are located around the perimeter of the site to identify any off-site contaminant migration.

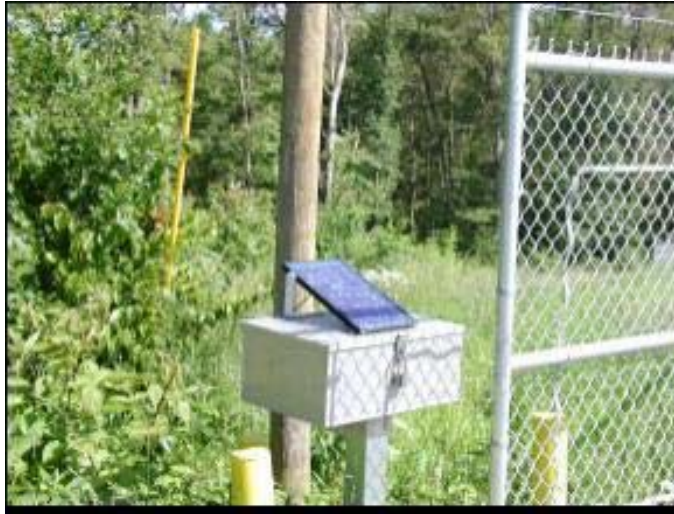
Figure 18. Photograph of groundwater monitoring station.

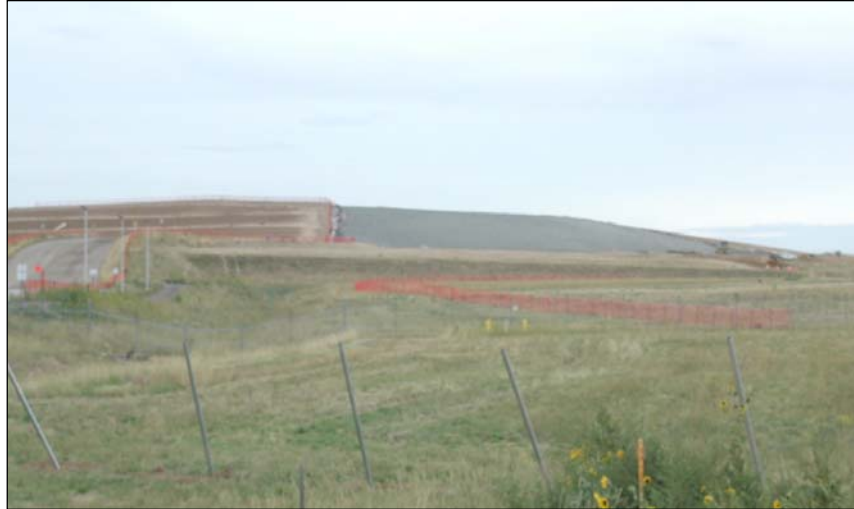
Figure 26. Photograph of RCRA landfill under construction at RMA.

RCRA-compliant landfill (see Figure 26).

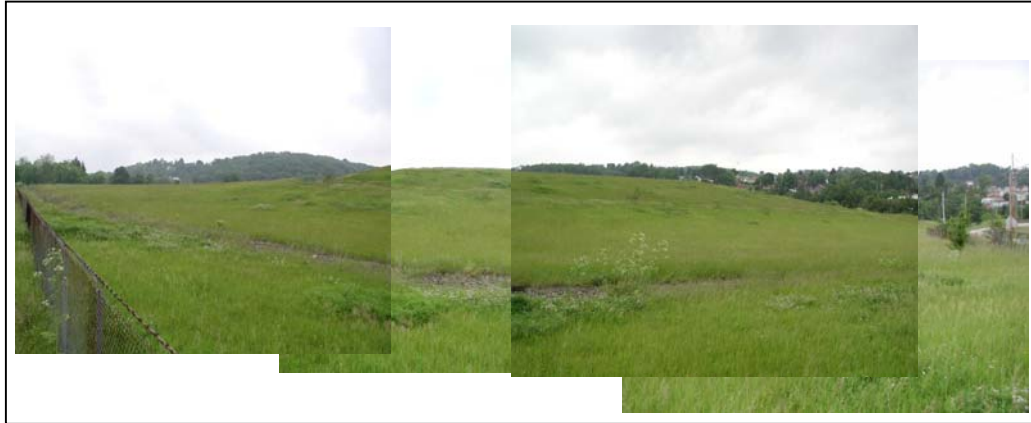
Figure 34. Photograph of Canonsburg UMTRCA Disposal Cell.

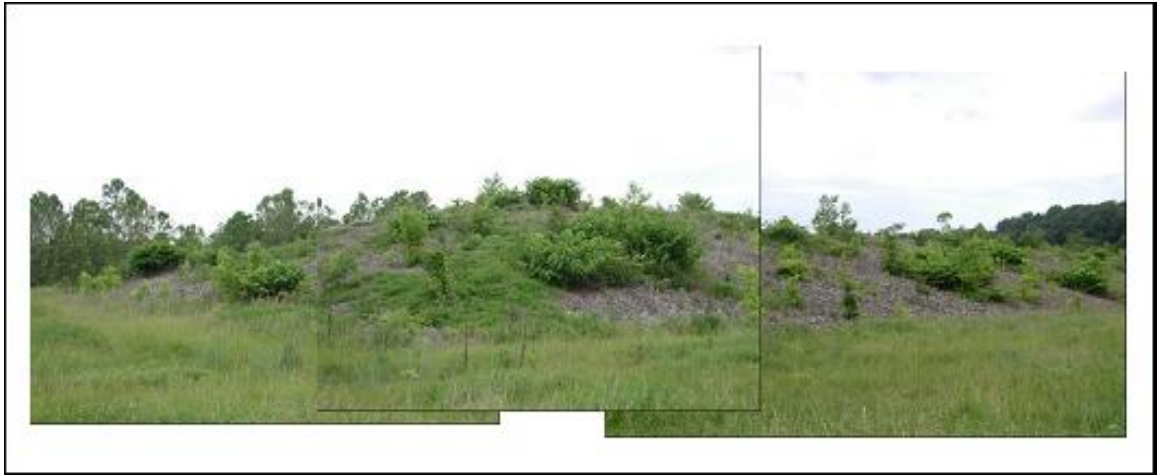
Figure 37. Photograph of Burrell UMTRCA Disposal Cell illustrating vegetative community present on riprap cover.

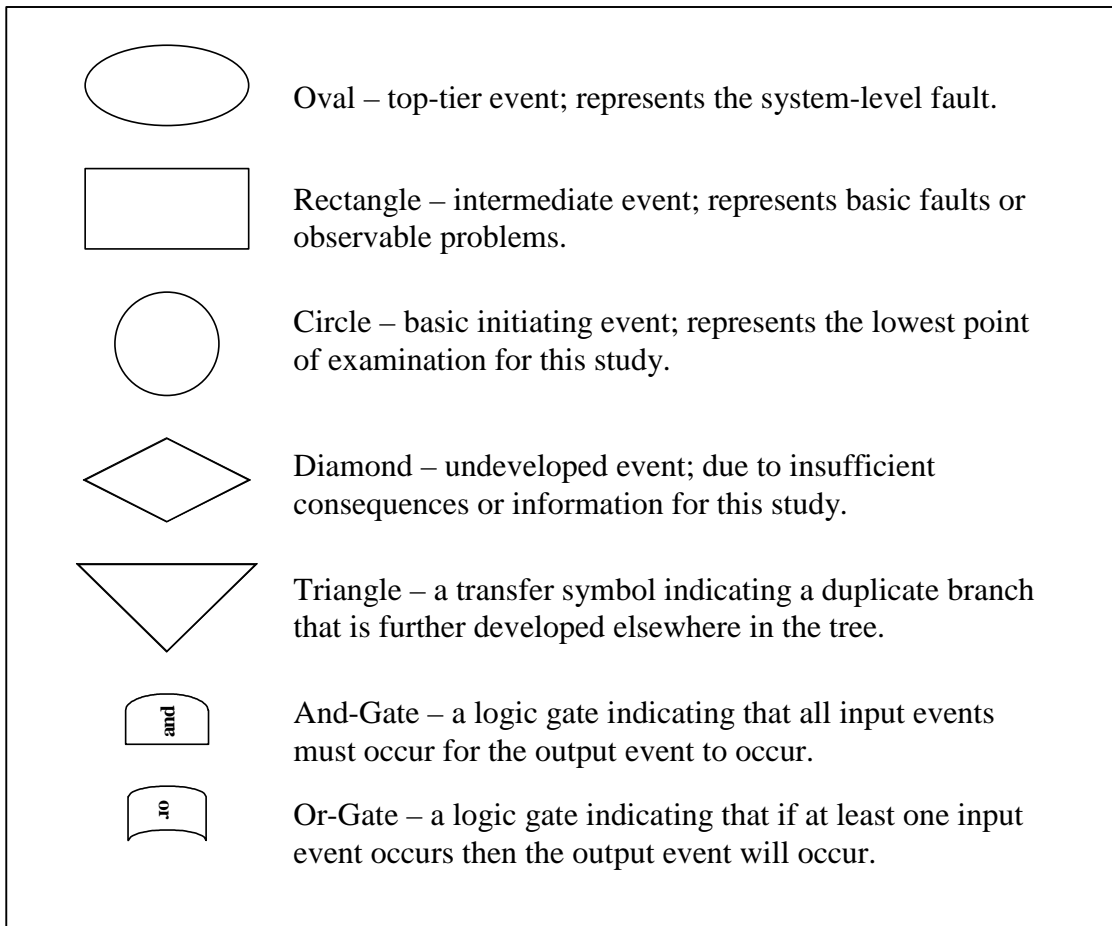
Figure 38. A simplified set of standard symbols is used in FTA to represent fault events and logic gates.

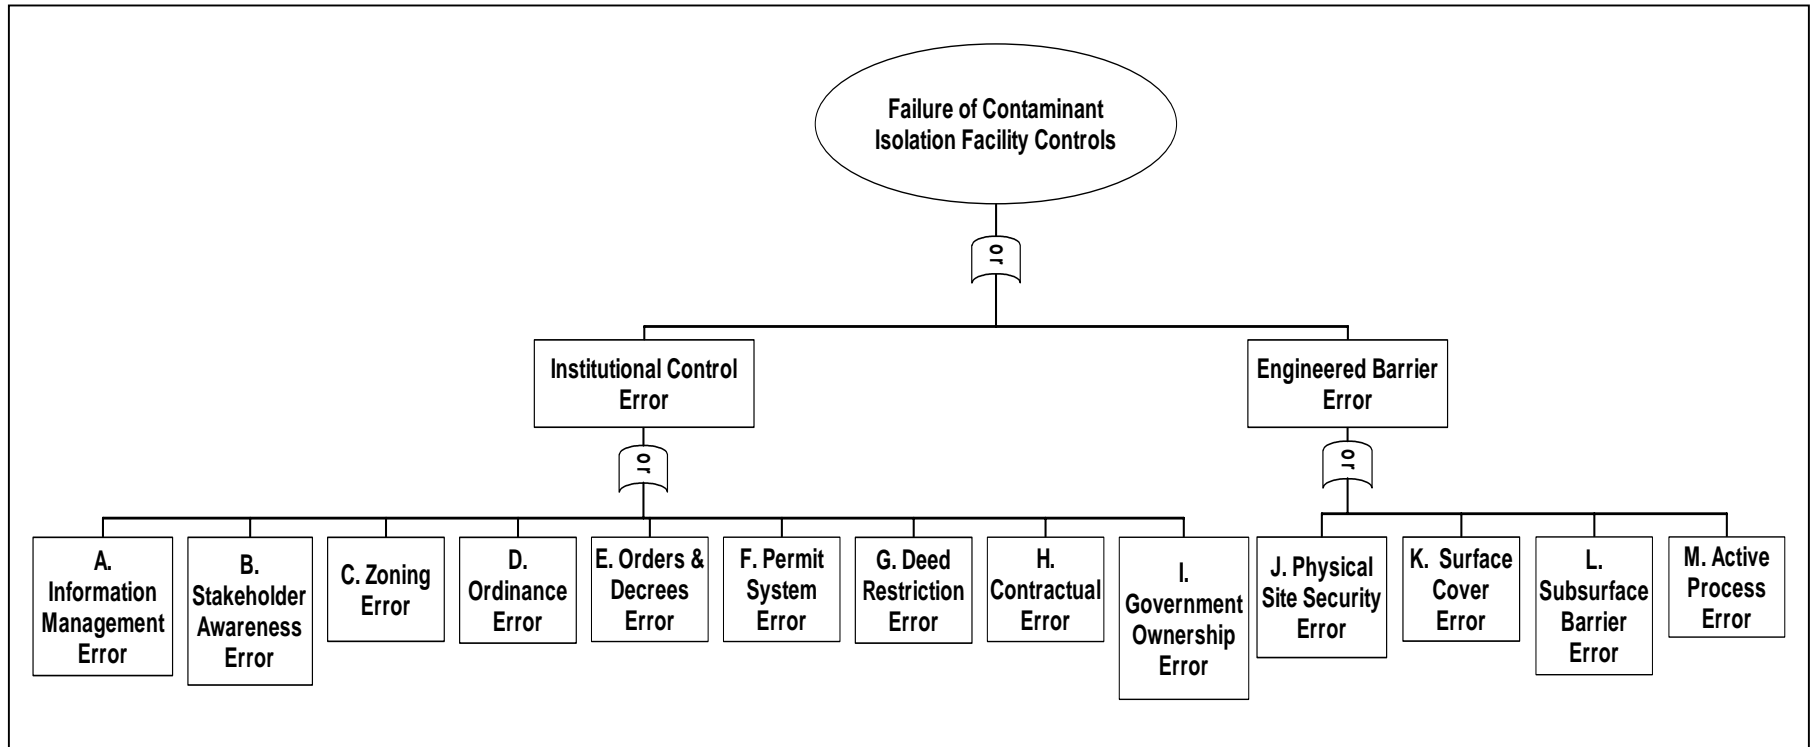
Figure 39. Contaminant isolation facility system-level and primary intermediate-level faults.

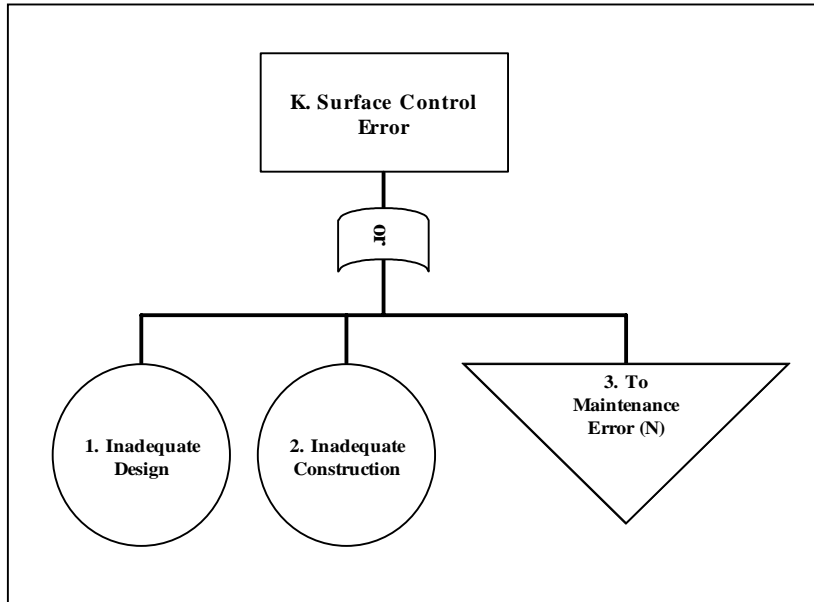
Figure 50. Surface Control Error branch.

presented in Table 30. The transfer symbol indicates that the maintenance portion of this branch is described elsewhere.

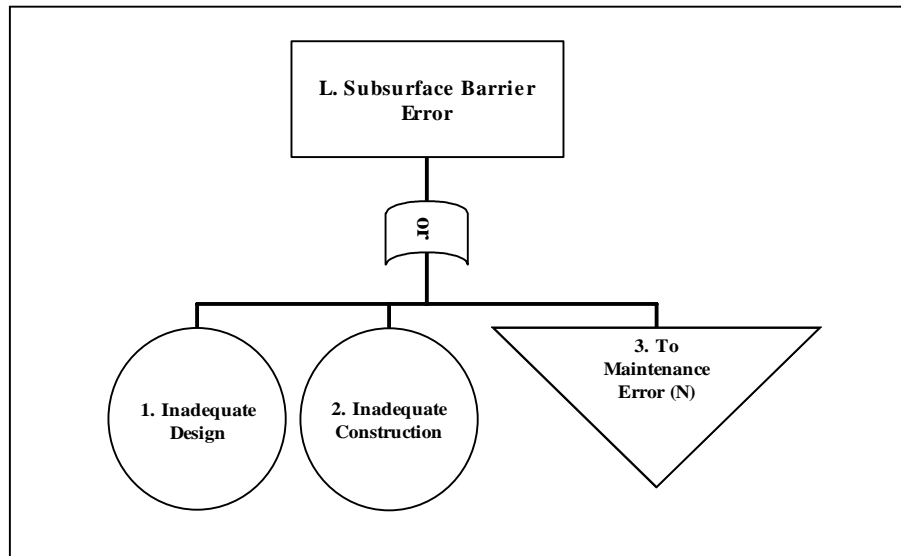
Figure 51. Subsurface Barrier Error branch.

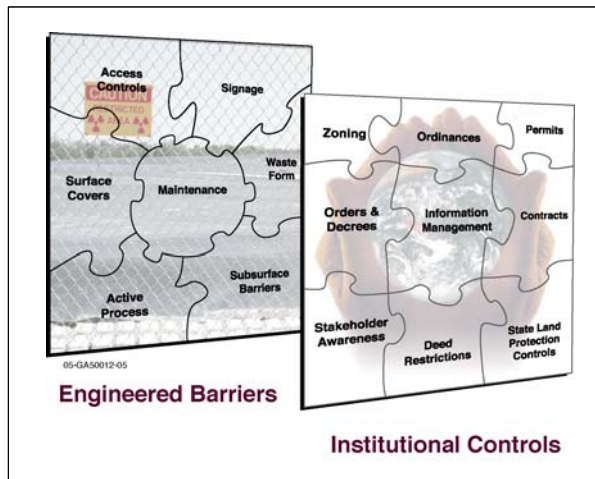
Figure 56. An illustration of the layering of engineered barriers and institutional controls.
